CASE STUDY

Municipal Solid Waste Litter Fence 1,200 Foot Perimeter Fence HLDA 1500

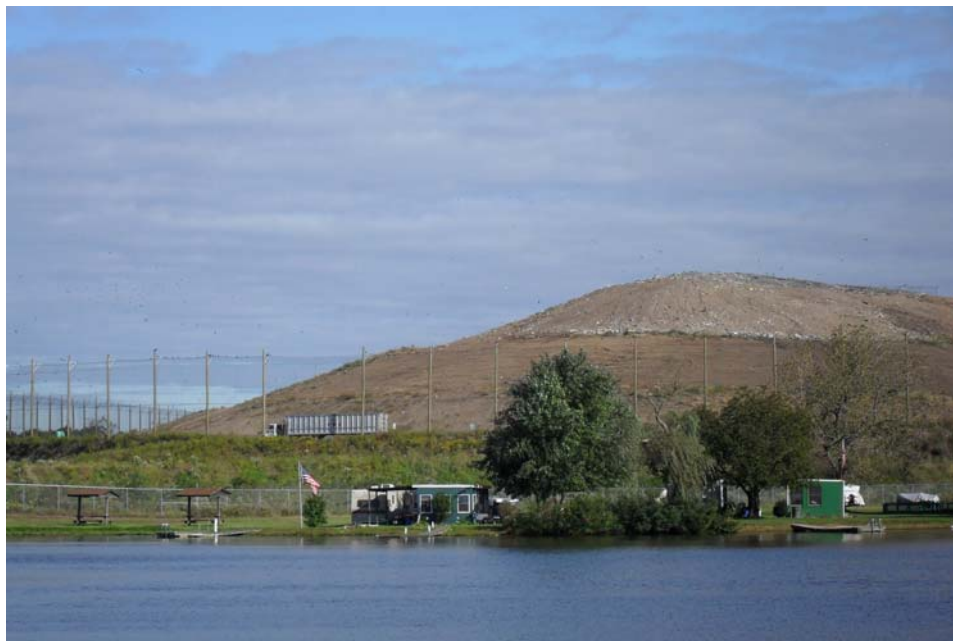
A two-man crew installed the system in three days. The base air line was 1,200 feet of 4" welded plastic pipe. Stanchions, 8 feet high, were attached to each litter fence pole. 3/16" holes were drilled through the 1" diameter stanchion to distribute the odor neutralizer.

The solution was to install a waterless, air-driven system along the base of the litter fence with stanchions on the poles. Because only air is driven through the system, the need for a man lift to maintain leaking and clogged nozzles was eliminated.
